Commercial cooling Tower Case Study - 90 Day Evaluation

Installer: Nano Tek-On - HydroFLOW Master Distributor in Hawaii.

Customer: Central Pacific Plaza Location: Honolulu, Hawai - USA

Unit: HydroFLOW 14" Custom on a 12.78" Outer Diameter Cast Iron Pipe

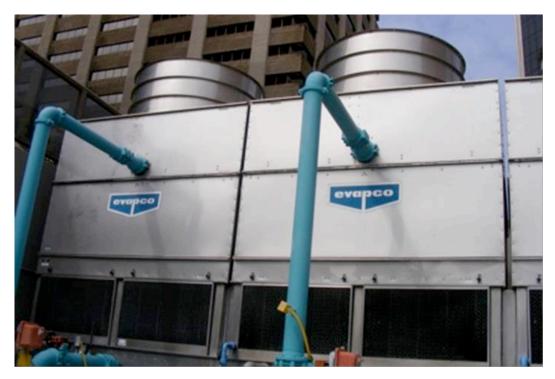
Cooling Tower Cells

Application: Two 300 ton cells and one 75 ton cell - One 300 ton cell operates during the day, one 300 ton cell is on

standby and the 75 ton cells operates during the night

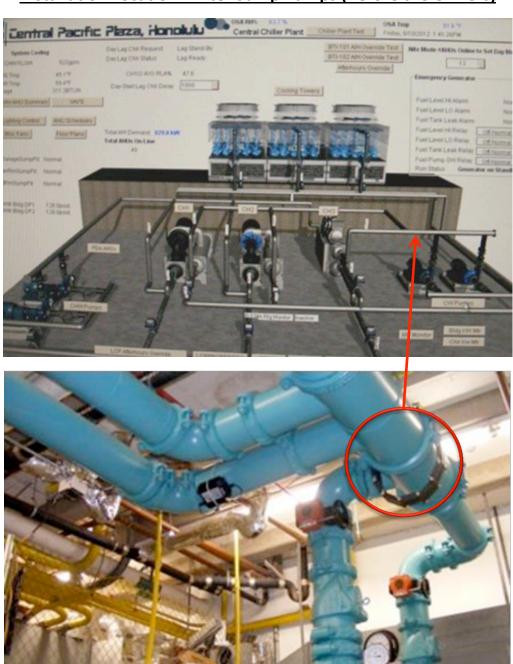
Installation Location - After Sump Pumps (Before the Chillers)

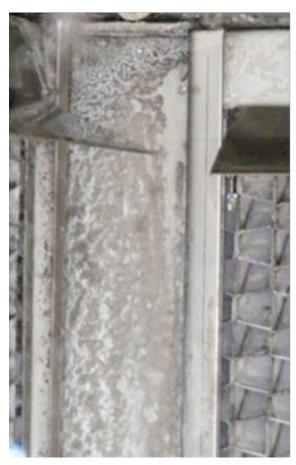
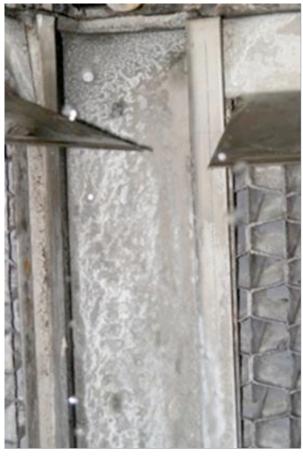
Before After

Lime scale and corrosion buildup remained under control even though anti-scalant and anti-corrosive chemicals were discontinued

- Lime scale and corrosion buildup inside the cooling tower and chillers remained under control even though antiscalant and anti-corrosive chemicals were discontinued
- Biocide chemical was reduced by 85% and bacteria levels reduced from 100,000 CFU to 1,000 CFU
- Blow-down reduced by 50%
- Conductivity remained stable at 1245 $^{\sim}$ 1295 Micro Siemens

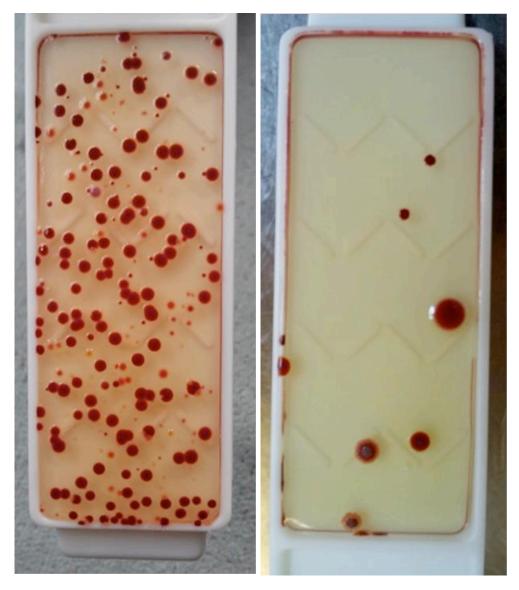
Before After

[Dip slides were used to monitor biological count]

Biocide chemical was reduced by 85% and bacteria levels reduced from 100,000 CFU to 1,000 CFU
